F-111 Adhesive Bonded Repairs Assessment Program - Progress Report 2: Analysis of FM300-2K Repairs

Eudora S. Y. Yeo

Aerospace Division
Defence Science and Technology Organisation

DSTO-TR-3088

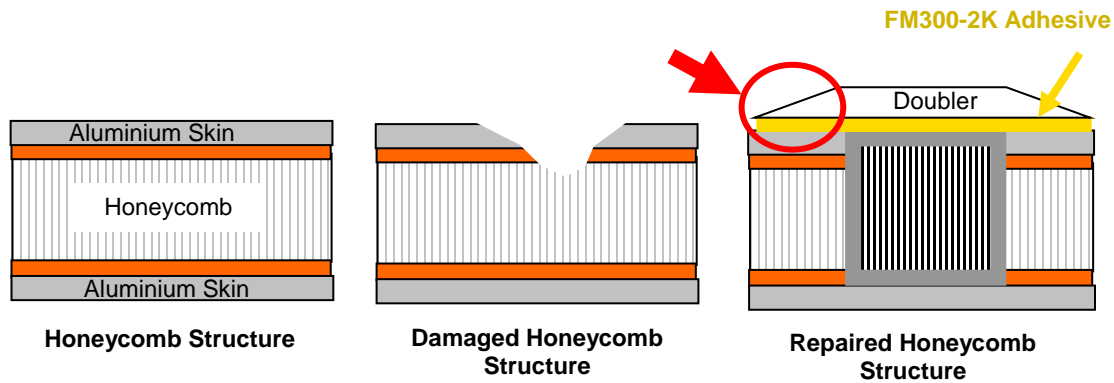
Figure 1 Typical honeycomb structure present on F-111 and common repair techniques used to re-establish airworthiness. The highlighted area in red indicates the focus of the bonded repair program, in which the adhesive bond of the applied doubler to the existing aluminium skin is interrogated to determine condition after service exposure.

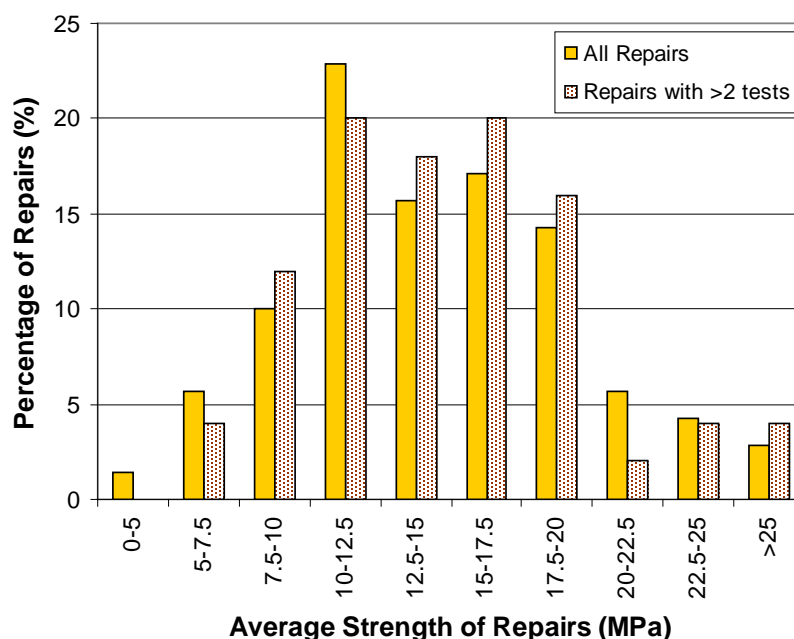
Figure 3 shows the strength distribution of the 50 bonded repairs which had two or more tests, alongside the 70 repairs which include those with a single test. The overall distribution in strength of the repairs with greater than two tests is similar to the total population set, and the average strengths of the full data set and reduced data set were similar, at 14.4 MPa and 14.7 MPa, respectively.

Figure 3 The distribution of repair strength for the 70 FM300-2K repairs tested during the bonded repair trial, and the 50 repairs for which there were two or more tests

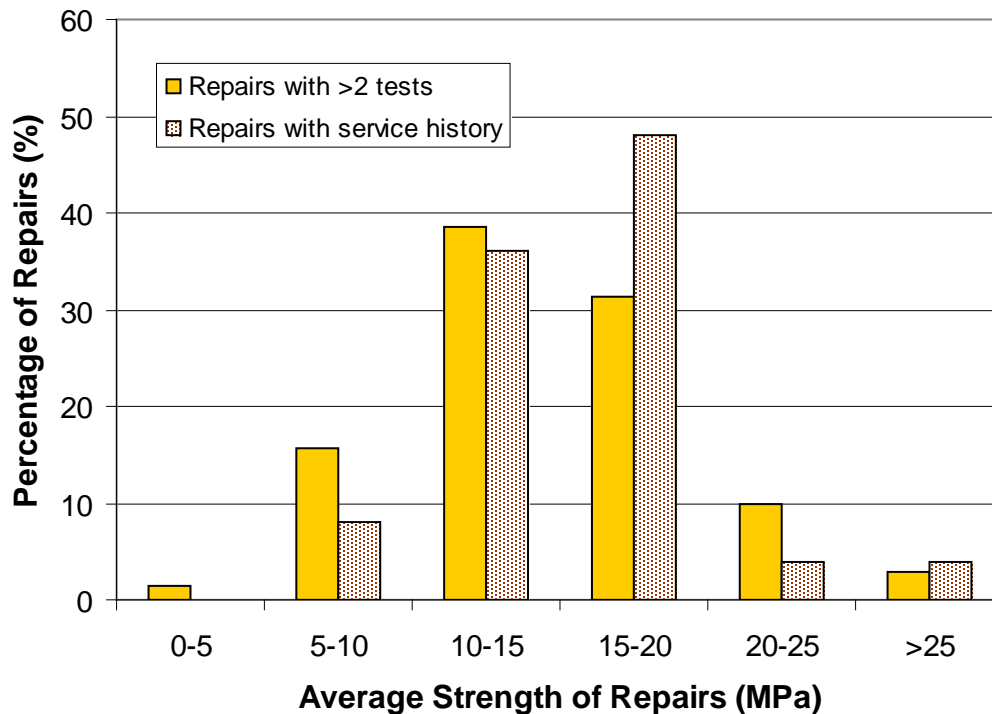
If repairs with no traceable service history are also excluded, the dataset is further reduced to only 25 repairs, with strength distribution shown in Figure 4. However a dataset of 25 may be too small to give meaningful results. Based on the previous study [4], which found that service history, based on either total accumulated time or total number of flight hours since repair application, had no discernible influence on repair strength, it was also decided to keep all the repairs for further analysis, not just those with a traceable service history.

Figure 4 The distribution of strength of the 25 FM300-2K repairs in which records detailing the repair application processes, dates of application and service history are available, compared with the larger data set of 50 repairs with two or more tests. The reduced data set may not be representative of the larger data set.

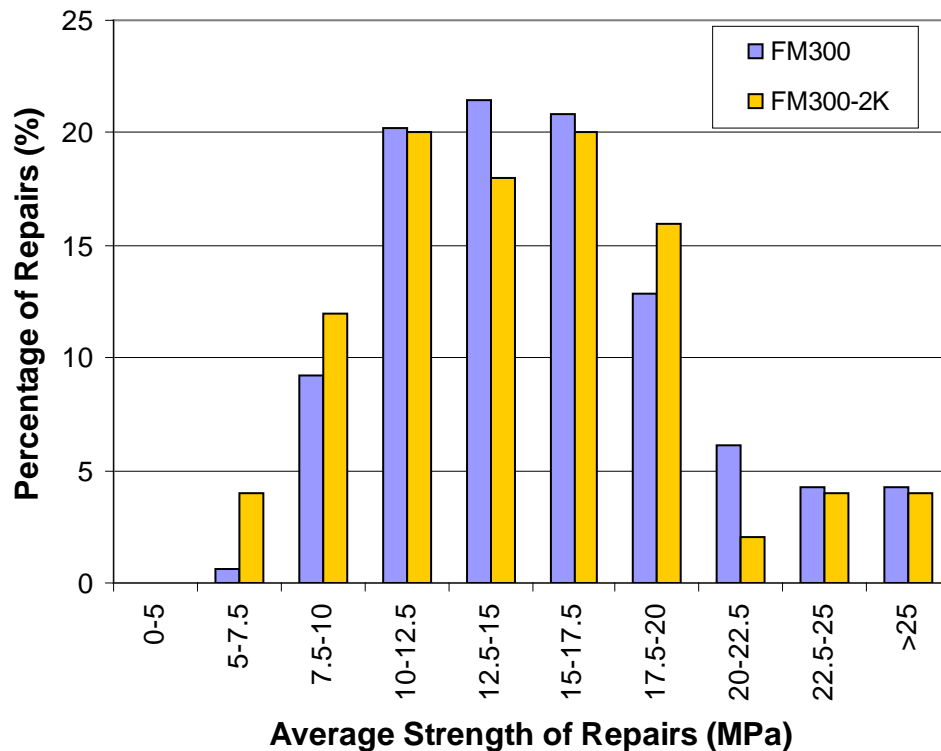
Figure 5 The distribution of repair strength for the 163 FM300 and 50 FM300-2K repairs tested during the bonded repair trial, for which there were two or more tests

The strength distribution of FM300 and FM300-2K repairs with two or more tests is compared in Figure 5 above. The average (mean) FM300 repair strength is 15.4 MPa, compared with 14.7 MPa for FM300-2K repairs, and the median repair strength is 14.8 MPa for both FM300 and FM300-2K repairs.

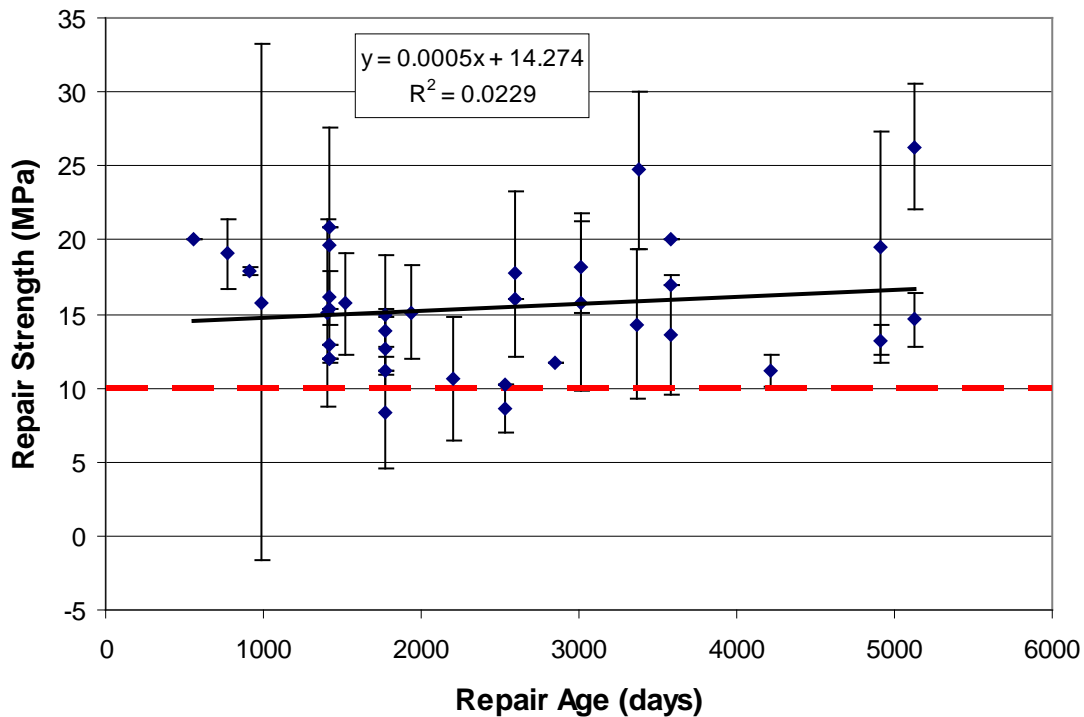
The initial analysis of the bonded repairs examined if a correlation existed with the average repair strength and the repair age (Figure 6). The repair age represents the total accumulated time since the repair was applied to the time the repair was tested. There is no correlation in strength with repair age as indicated by the wide distributions of strength that exist for the repairs ranging between 500 and 5100 days or around 1.5 to 14 years. The extent of variation for discrete repair ages is greater than the difference in the average value for nearly all the data. Two repairs, A8-112-22 and A8-512-05 fall below the expected lower limit. These will be examined in further detail in Section 4.1.2.

Figure 6 The repair strength measured as a function of total age of the repair where the error bars represent the 95% confidence interval. The broken red line represents the lower limit expected for undegraded bonds accounting for possible geometrical variations in loading.

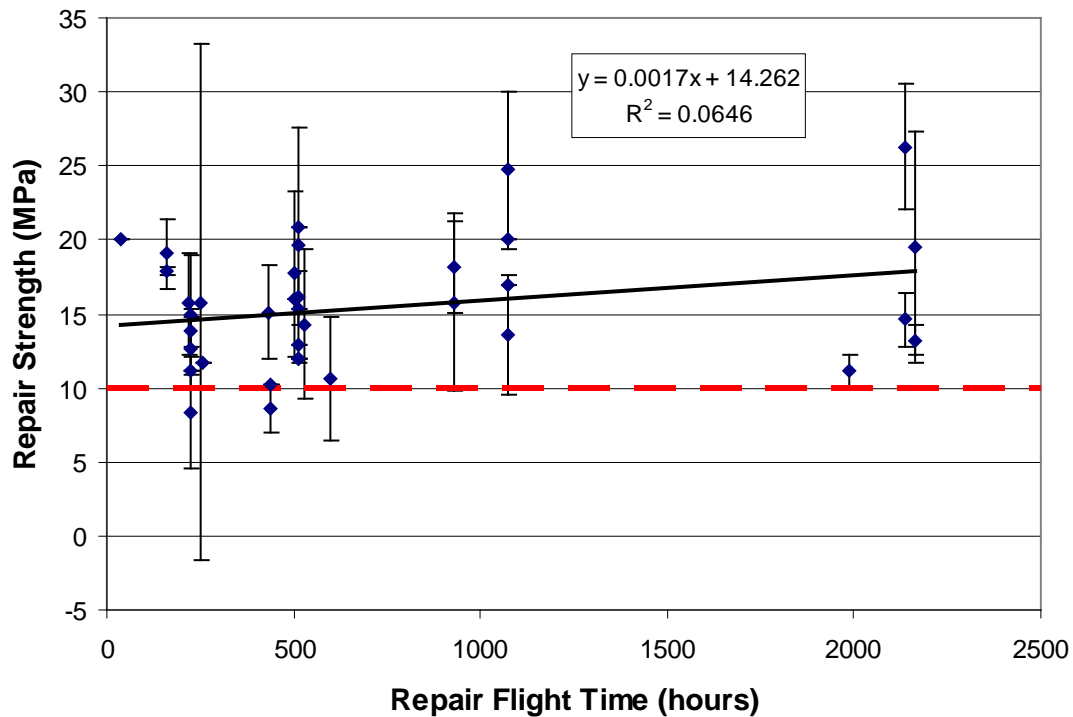
Figure 7 indicates the average repair strength as a function of accumulated flight hours. The data is similar to Figure 6 and shows that the strength does not depend on the accumulated flight hours, with the variation of repair strength at discrete times being typically greater than the average strength over a period between 100 and 1600 hours. The two repairs that fall below the expected lower limit are the same as those in Figure 6.

The results from both Figure 6 and Figure 7 suggest that, it is equally likely that a repair randomly measured for strength over a period of at least 5000 days of total life or 2100 hours flight time or both will have an average strength around 15.8 MPa with a 95% confidence interval around ± 2 MPa. These initial results show that with 95% confidence, a minimum strength around 13 MPa would be expected for the total lifetime of the repairs examined. This is above the 10 MPa lower limit which was nominated for repairs manufactured using FM300 film adhesive, when accounting for variation in bondline strength that would simply be due to geometrical loading effects, discussed in the previous report [6]. However the strength of two repairs fall below 10 MPa, and further analysis of these repairs is undertaken in the following section.

Figure 7 Correlation between flight hours experienced by each repair and average repair strength, where the error bars represent the 95% confidence interval for all repairs measured with the same accumulated flight hours. The broken red line represents the lower limit expected for undegraded bonds accounting for possible geometrical variations in loading. Single data point repairs have been excluded.

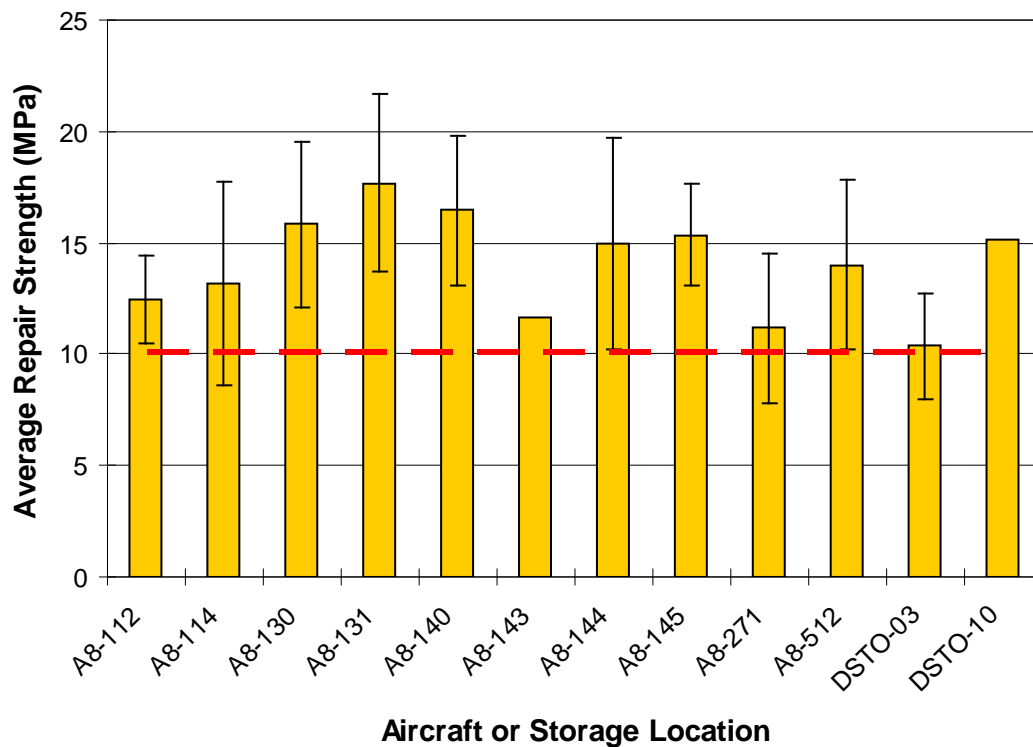
Figure 8 Average repair strength for each aircraft examined or for components recovered from storage locations. The dataset has stub results reported in Table 2 removed. The broken red line represents the lower limit expected for undegraded bonds accounting for possible geometrical variations in loading.

Specifically, repairs number three, four and five from A8-114 had ten pull stub tests carried out between them and eight of the ten tests had strengths below 10 MPa. On Aircraft A8-271, all three stubs on repair 5 had strengths lower than 10 MPa. On repair 13, all three stubs had strengths below 10 MPa, as well as all three stubs on repair 14, and two of the three stubs on repair 18. Where the repair strength average of all stubs dropped below 10 MPa, the individual stubs were examined in further detail, shown in Table 3. It

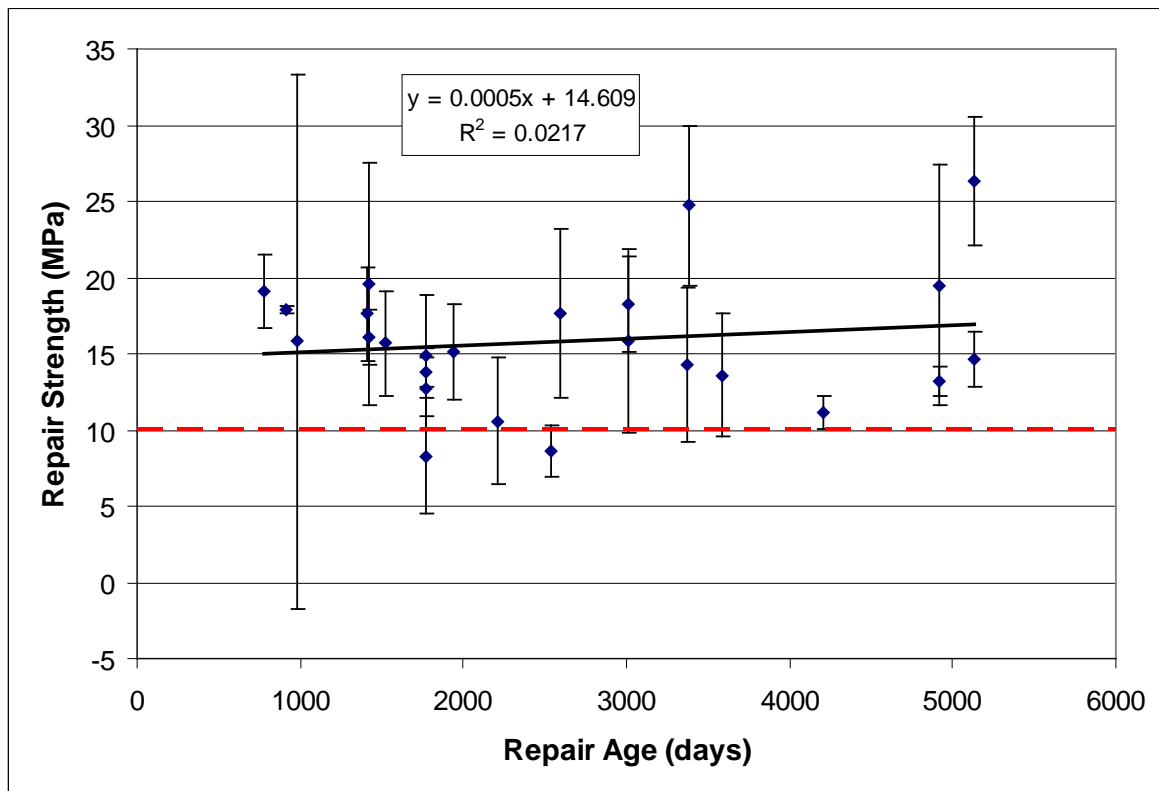
Figure 9 shows the average repair strength as a function of total repair age for the modified dataset where individual stub results from Table 2 were removed from the original dataset, as well as any repairs where only a single adhesion stub was tested. The results show that the average repair strength across the 15 years is around 15.8 MPa with a standard deviation of 4.2 MPa and 95% confidence interval around ± 2 MPa. The lack of correlation between repair age and strength provides an encouraging indication that the strength of the bonded repairs does not appear to be affected over a considerable period of time. Generally, the spread in data appears to be relatively consistent over the period of the analysis, which suggests that the variability in strength measurements is inherent in

Figure 9 The average repair strength as a function of total accumulated time since application, where individual stub results from Table 2 were removed as well as repairs where only a single stub was tested. The broken red line represents the lower limit expected for undegraded bonds accounting for possible geometrical variations in loading.

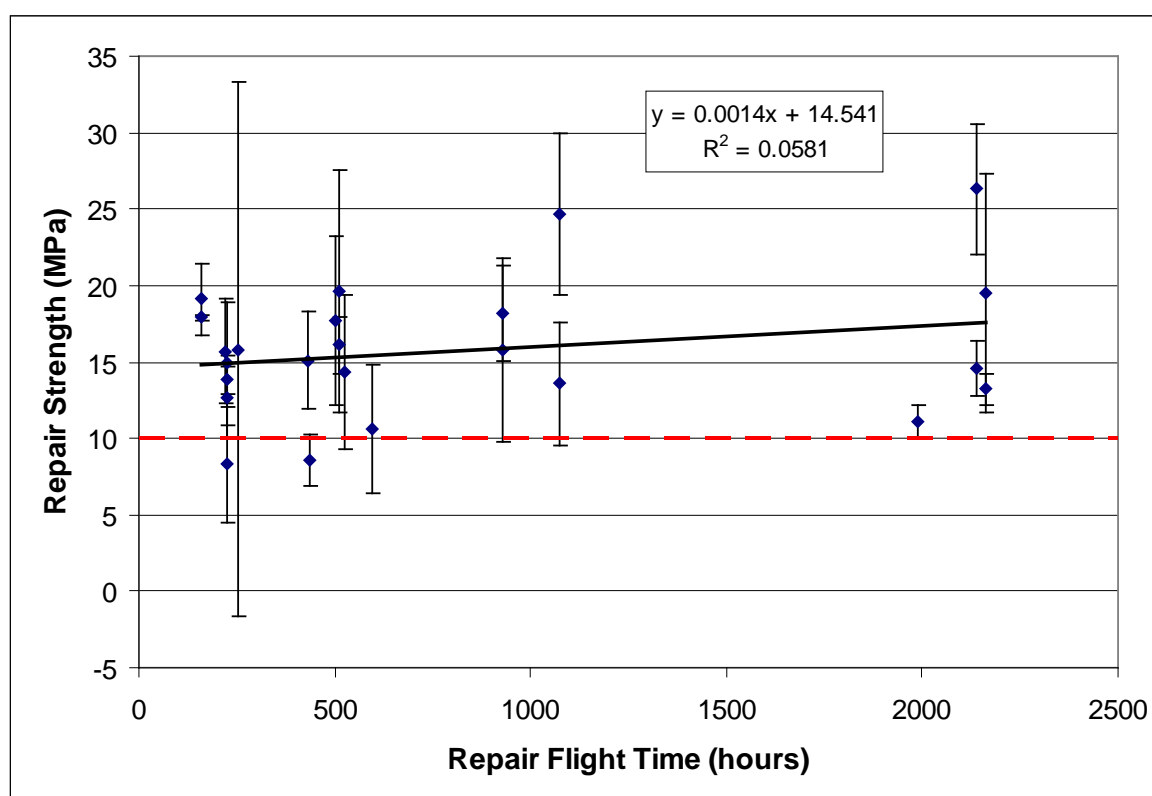
Further analysis of the dataset in Figure 9 examined the trend in repairs where the flight hours were confidently known through a review of available paperwork, and this is shown in Figure 10. This reduced the number of repairs to 24. However, it can be seen that the trend in Figure 10 is similar to Figure 9 and Figure 7, with average repair strengths across the 2100 flight hours of data having similar average values and similar confidence limits. The average strength is 15.7 MPa with a standard deviation of 4.3 MPa and 95% confidence interval around ± 2 MPa.

The two repairs in Figure 9 and Figure 10 with strengths below 10 MPa are the same as in Figure 6 and Figure 7, outlined in Table 1 and examined at the beginning of this section. The two repairs with low strength had very low flight hours, and the lack of correlation

Figure 10 Only repairs with a traceable service history have been included in this data set. This reduced the number of repairs to 24.

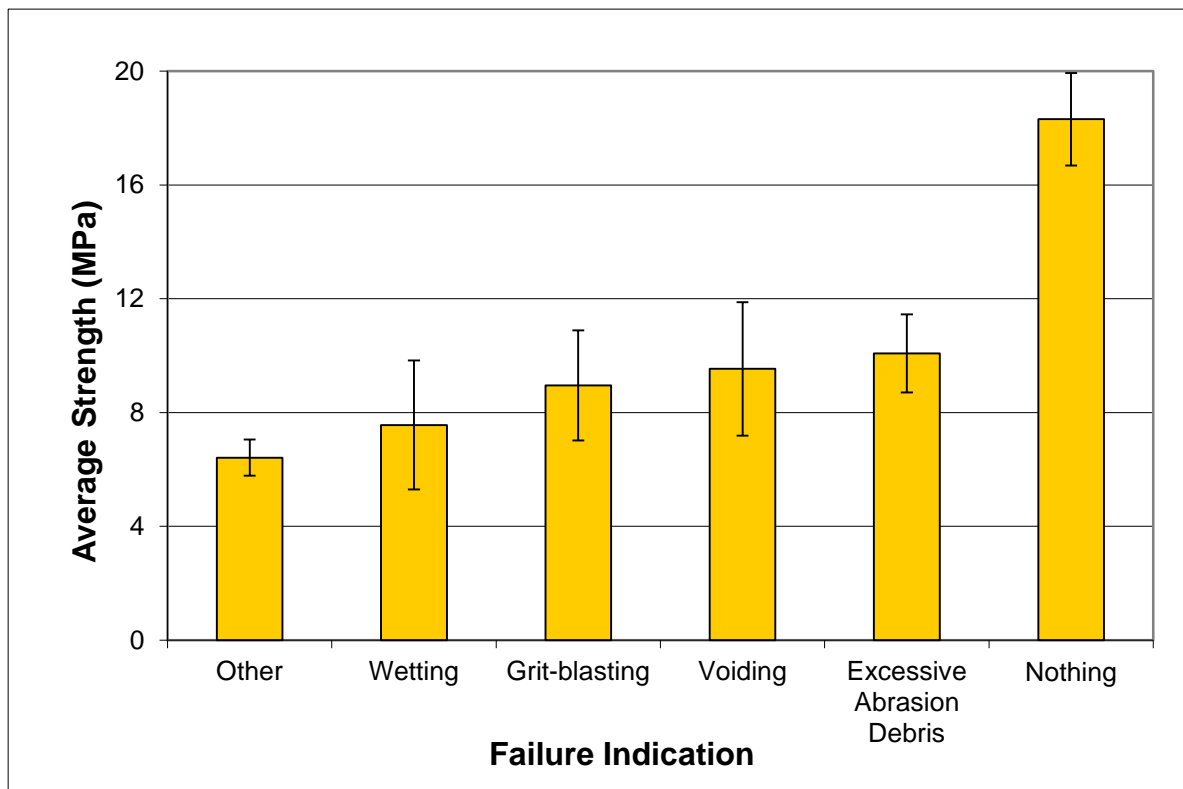
A summary of the failure indications and the average strength associated with each type is provided in Figure 12 below. Many stubs had two or three possible failure indications, in which case the stub was counted against each category. The results indicate the average strength for each indication type, with the spread in data shown by error bars, which represent the 95% confidence limits. The plot provides a useful measure of the relative severity of each type of failure with respect to the reduction in the overall stub strength in the locally affected areas. Stubs that fell into the “other” category had the lowest strength. One stub was close to a fastener hole, and this stub is examined in detail in Section 5.2. One stub had an operator comment that the stub may have failed in the peel mode rather than pull-off tension due to test configuration, and three more were on highly curved surfaces which have a higher likelihood of being affected by peel due to piston misalignment. It is understood that a peel failure component leads to a lower measured pull-off tension strength. However, it is difficult to exclude repairs on curved surfaces as the majority of aircraft surfaces are curved. Several stubs from repair 271-12 were placed in the “other” category, as this repair showed a severe deficiency in bond preparation, which will be examined in further detail in Section 5.1.

Excessive voiding was originally noted as a possible cause of failure, however, as shown in Figure 12, the average strength of stubs that presented voiding was 9.5 MPa, which is only slightly lower than the nominal “pass” value of 10 MPa. The presence of excessive abrasion debris, thought to indicate poor cleaning, was originally noted as a possible cause of low failure strength, however with an average strength of 10.1 MPa and with excessive abrasion debris present on many high strength stubs, the effect on the bond strength may be minimal, as discussed in further detail in Section 5.1.

Figure 12 Average strength for individual pull-stubs with failure indications categorised according to problems with adhesive wetting (wetting), inadequate grit-blasting (grit-blasting), high levels of voiding (voiding) adhesion failure with no identified cause (adhesion failure), and uncategorised causes (other). The strengths are compared to stubs measured on the same repairs without any indications (nothing).

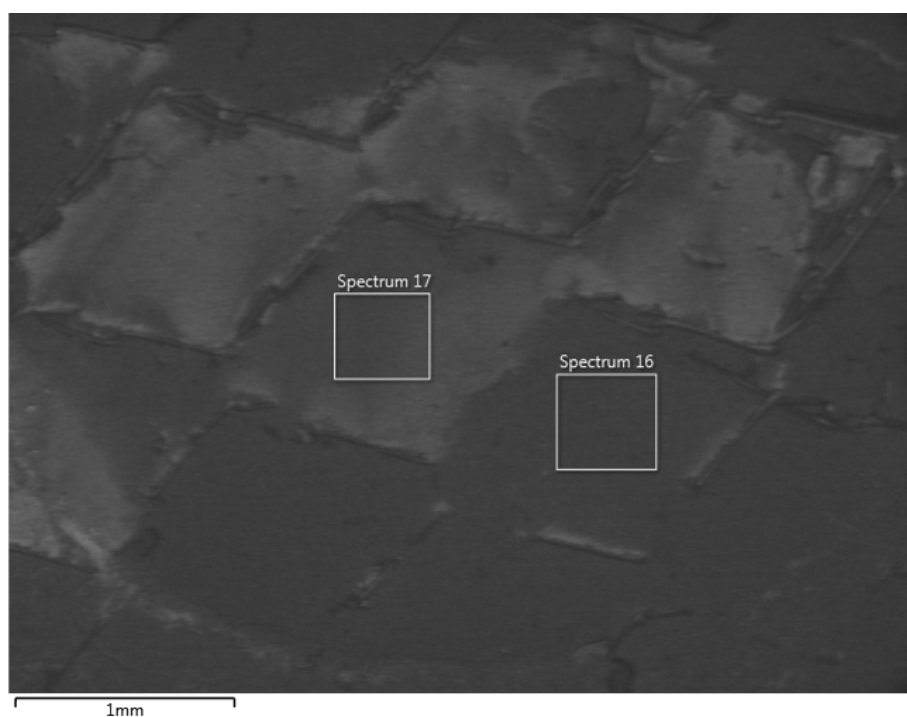
Figure A 1 Spectra 16 and 17 were taken on the surface matching the rivet head location

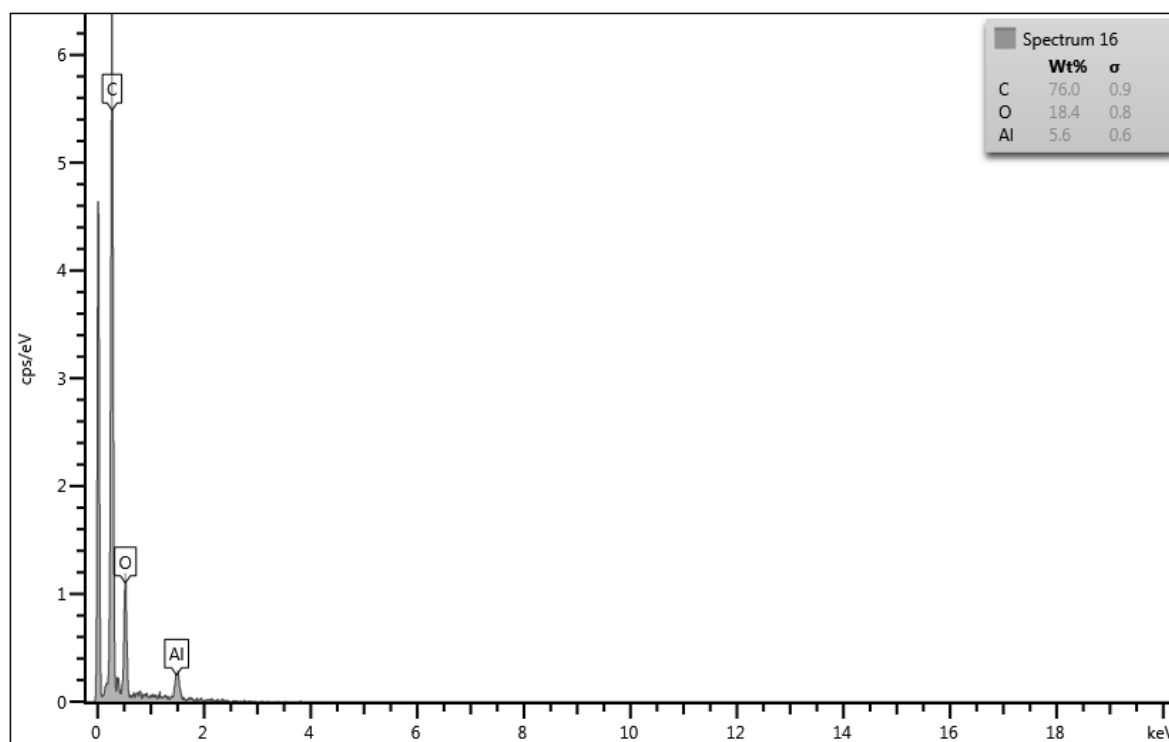
Figure A 2 Spectrum 16 was taken on the surface matching the rivet head location

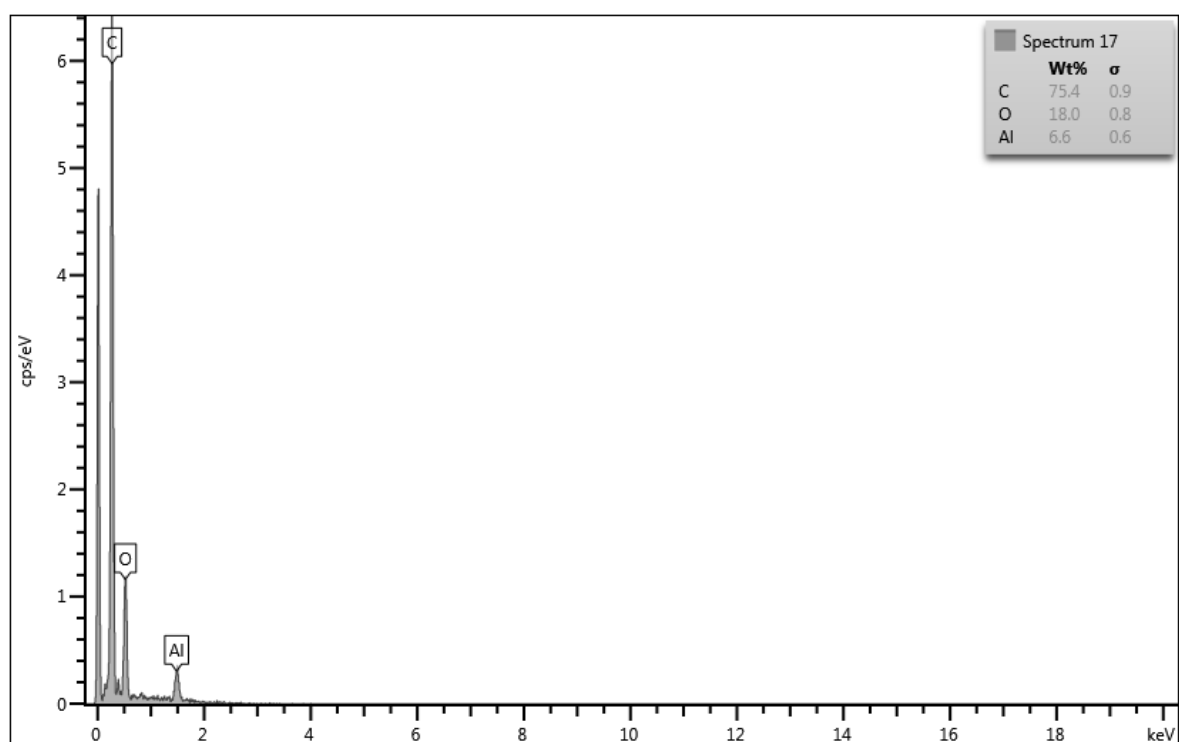
Figure A 3 *Spectrum 17 was taken on the surface matching the rivet head location*

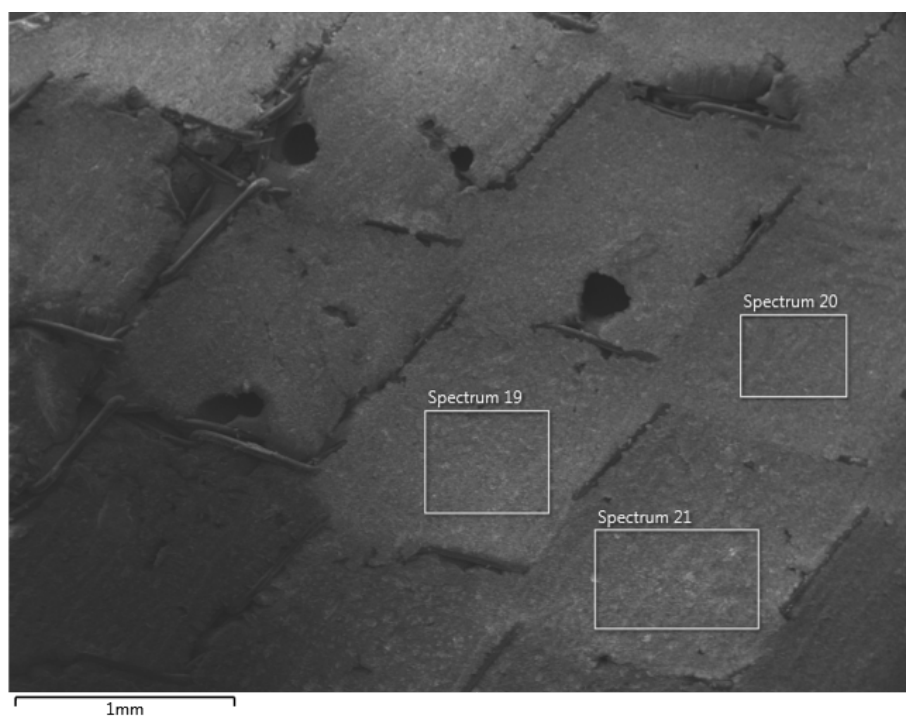
Figure A 4 *Spectra 20 and 21 were taken away from the rivet head location*

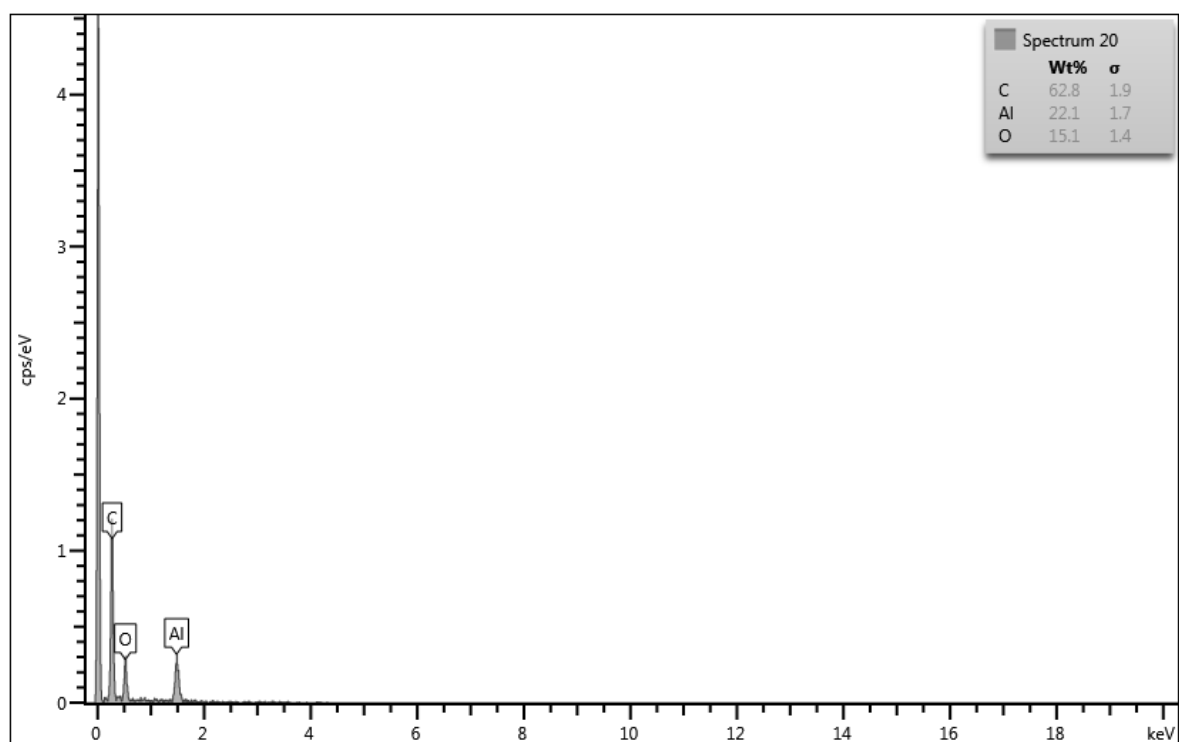
Figure A 5 Spectrum 20 was taken on the surface away from the rivet head location

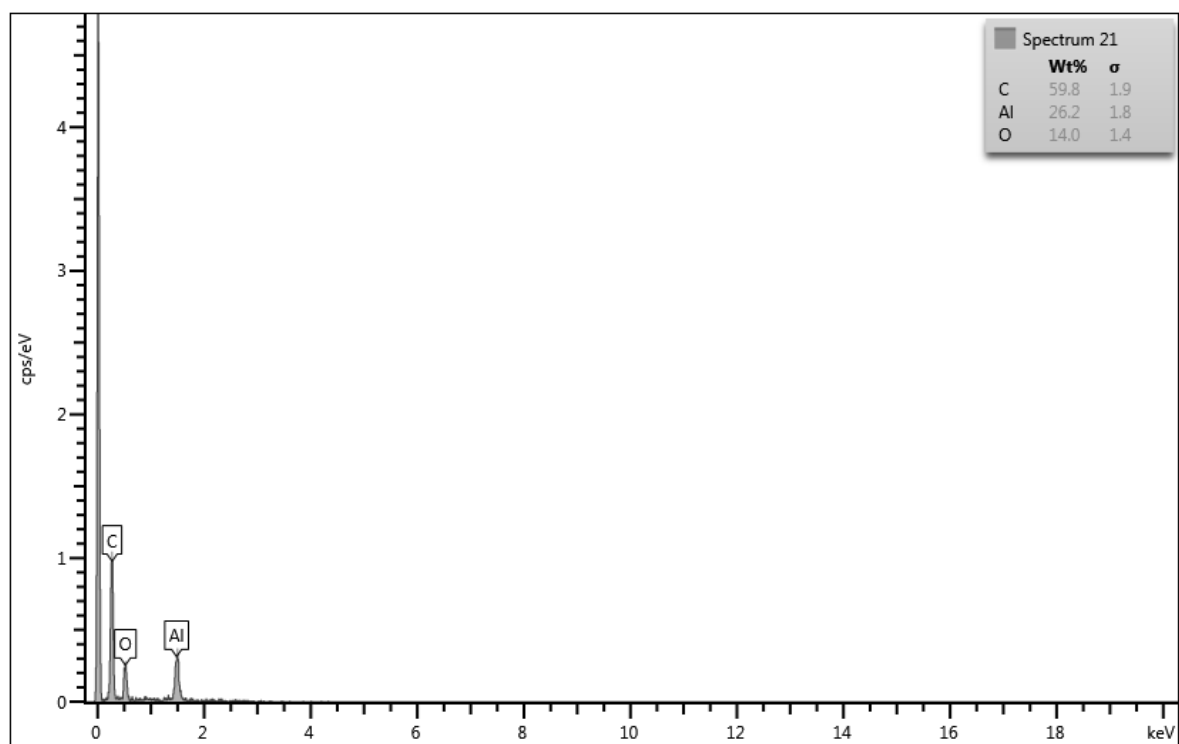
Figure A 6 Spectrum 21 was taken on the surface away from the rivet head location
